Title of Thesis: Field Assessment of Crowchild Trail Bridge

FIELD ASSESSMENT OF CROWCHILD TRAIL BRIDGE

STRUCTURAL ENGINEERING

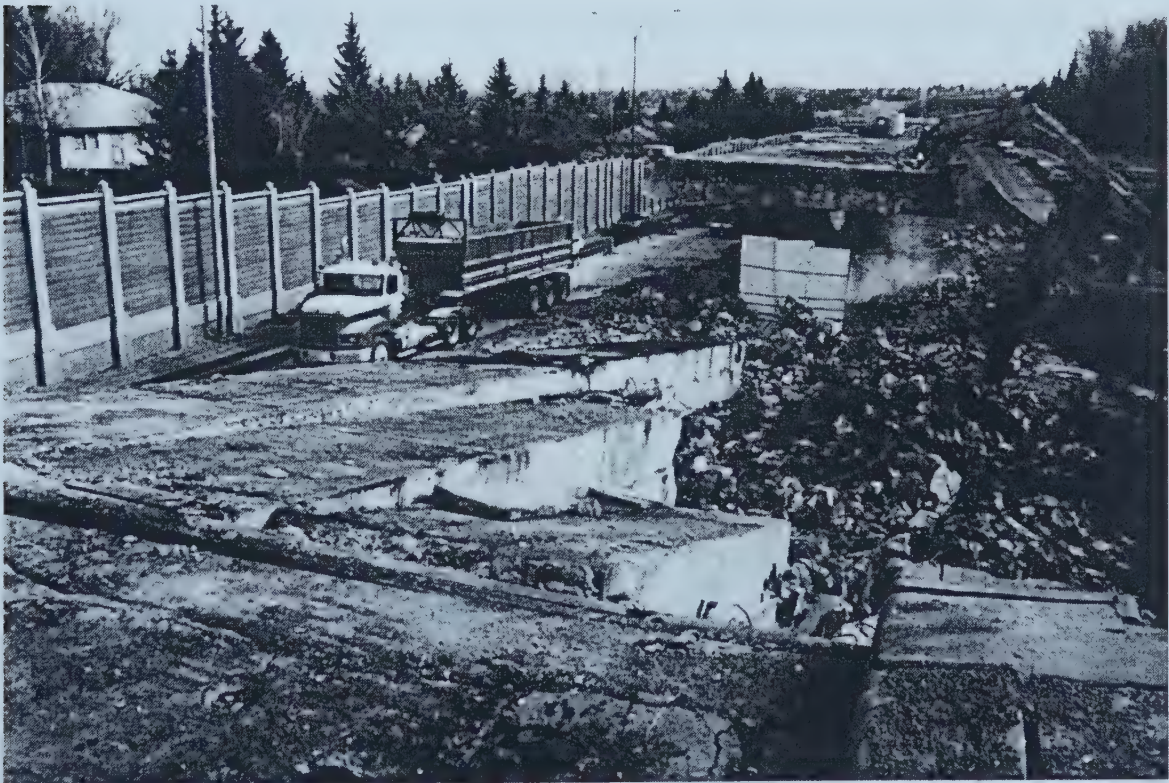
Photo 3.1: Old Crowchild Trail Bridge Superstructure under Demolition

The Crowchild Trail Bridge is a two-lane, one-way traffic overpass located on the intersection of Crowchild Trail and University Drive near the University of Calgary. The original superstructure was a three-span prestressed concrete box-girder bridge designed for HS20 truck loading. Each span is simply supported, and pretensioned longitudinally. Due to a large increase in traffic loads and rapid deterioration of the superstructure, it was necessary to replace the superstructure of the bridge. Photo 3.1 shows the old Crowchild Trail Bridge concrete box girder system during demolition.
